Inspection Report

Station: Anystation Unit: 10 Report Name: 14-Sec Superheater Front Pend

AREA: Secondary Superheater Front Pendant

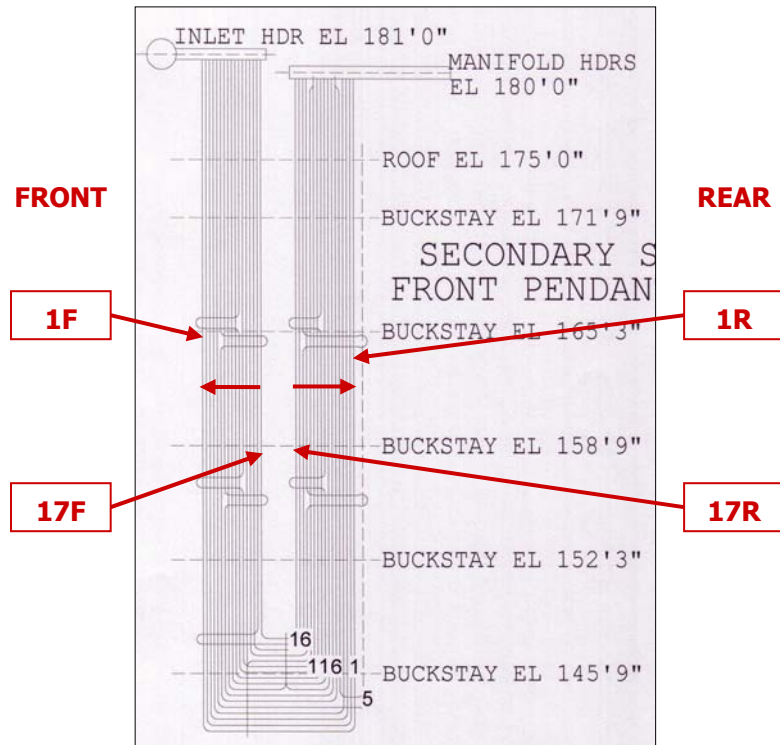
Tube Numbering Nomenclature

The area was numbered from boiler left side to boiler right side. See the diagram below for specific tube numbering nomenclature.

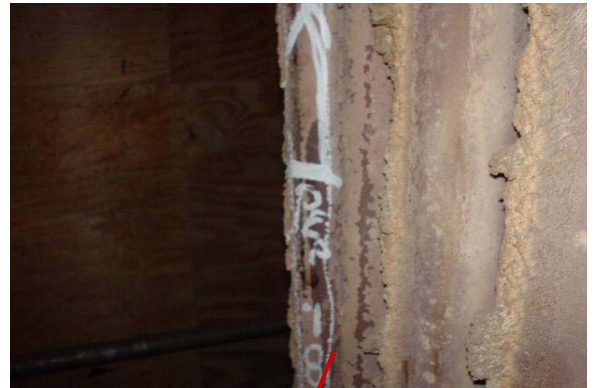
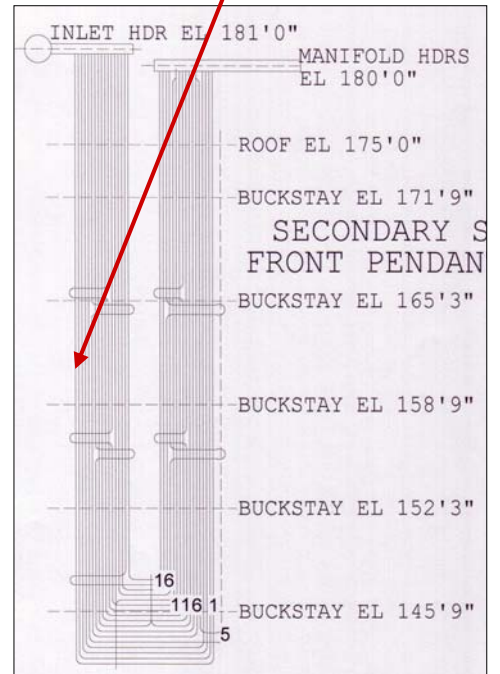
Repair #: 93-a Record:# 174
Action: TUBE REPLACEMENT
Priority #: 1

General location is Sec Superheater Front Pend, IK L/R 6 Blower Path
Elevation: 160'

Appearance: Erosion Flat

Material: 2.0" OD x .354" MWT x SA-213T22

UT Result: 0.093"

Install a 3' dutchman on tube 1F of assembly 19. The cut lines should start 6" below the tube tie weld and extend upward for 3'. This replacement will require a dissimilar metal weld. The lower material is SA-213-321H and the upper material is SA-213-T22.

UDC recommends installing a 'safe end' at this location. The dissimilar metal weld of the safe end is welded with inconel under controlled conditions. The inconel minimizes the differential expansion rate of the two differing materials. After the tube is replaced, re-align the tube with the assembly to prevent future degradation by erosion.

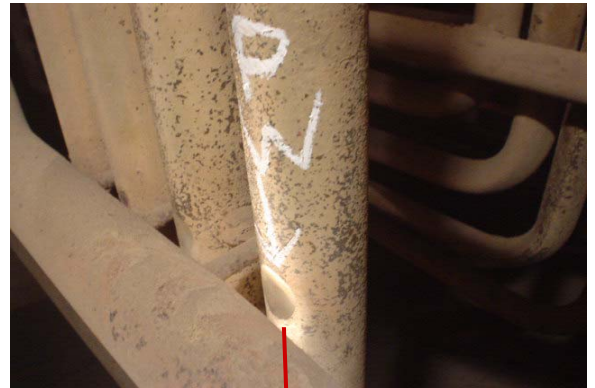
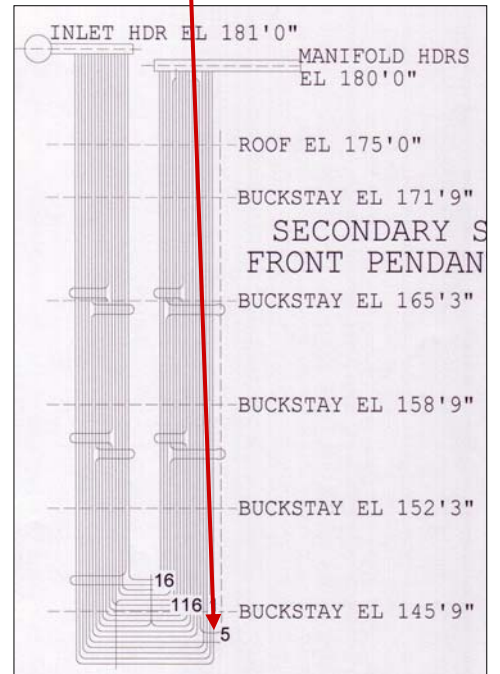
Repair #: 94-a Record:# 187
Action: PAD WELD
 Priority #: 1

General location is Sec Superheater Front Pend, Trailing Side.
Elevation: 144'

Cause: Abrasion Damage or Mechanical Rub
 Appearance: Abraded

Material: 1.75" OD x .230" MWT x SA-213TP321H

The secondary superheater tubing has been abraded from the wrapper tube on the right side of the assembly for an estimated depth of 1/16". Restore the tubing to MWT by applying a 2" pad weld at the following assembly(tube):

- 39 (1R)
- 41 (1R)
- 42 (2R)

After the pad welds are completed, install a 6" wear shield centered off the ssh wrapper tube on the right side.
