Inspection Report

Station: Anystation Unit: 10 Report Name: 14-Sec Superheater Front Pend

AREA: Secondary Superheater Front Pendant

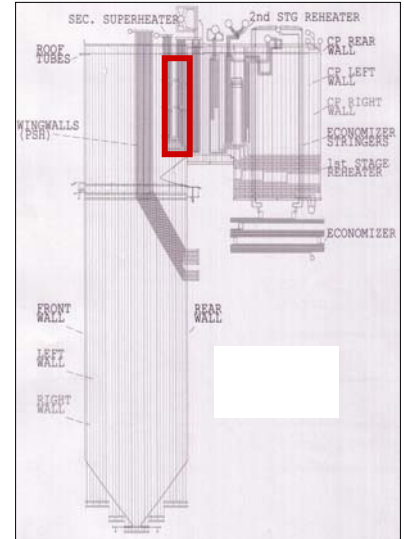
Tube Numbering Nomenclature

The area was numbered from boiler left side to boiler right side. See the diagram below for specific tube numbering nomenclature.
